# PRELIMINARY ENGINEERING REPORT AND BUILDING CONDITION SURVEY

TOWN OF BYRON
HIGHWAY DEPARTMENT BUILDING

GENESEE COUNTY, NEW YORK

**SEPTEMBER 14, 2016**

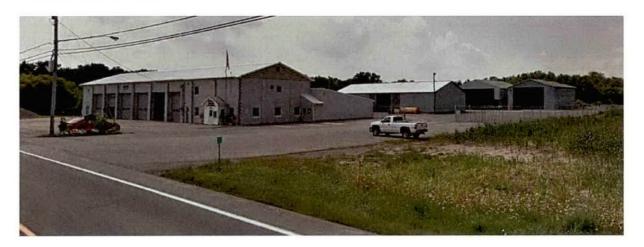
**Town of Byron Buildings, 2016.** From the left: Highway Barn, connected to Town Hall. Unconditioned Storage barn. 2 Salt barns.

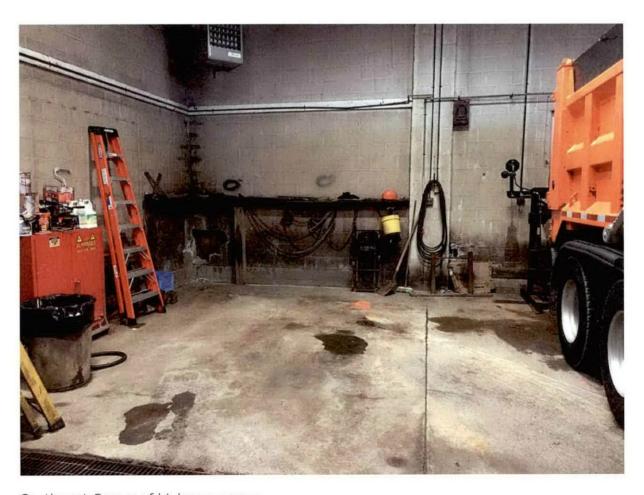
Southwest Corner of highway garage

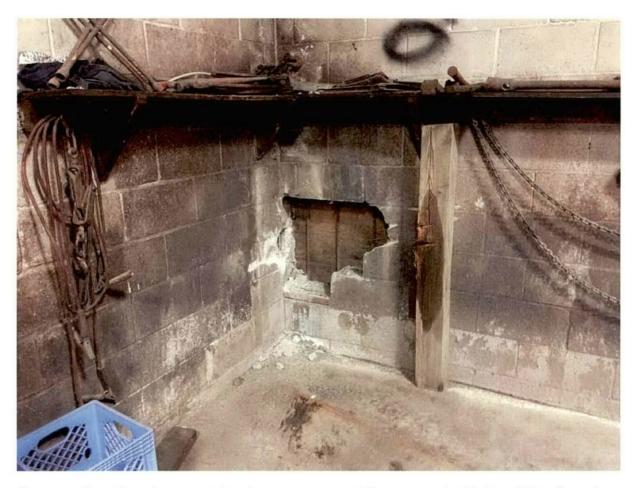
Close up of southwest corner, showing area removed from concrete block wall to allow plow to fit in barn.

- 5) The toilet rooms are not ADA compliant.
- 6) In order to pull the trucks in the garage with snow plow equipment, it was necessary to carve a cavity in the concrete masonry wall, since the building depth is inadequate.

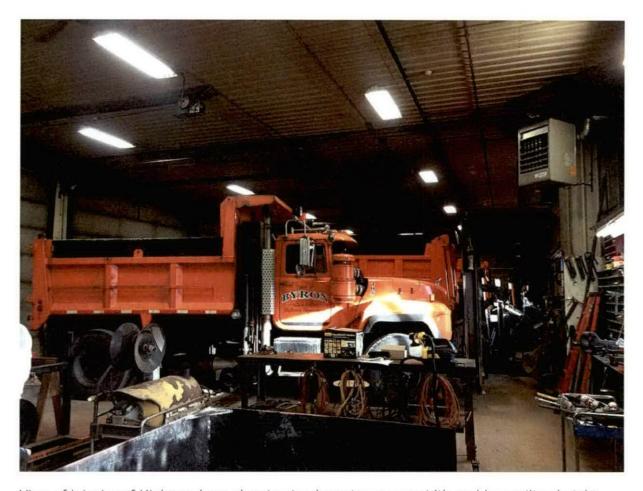
View of interior of Highway barn showing inadequate egress width and low ceiling height.

- 1) The egress paths around the trucks in the garage are inadequate, presenting life safety issues in the event of an emergency.
- 2) The ceilings are too short to allow the truck dump bodies to be raised to the full up position. This renders important safety equipment on the trucks useless, as they need to be used when the dump body is fully extended. This represents a very dangerous life safety condition.

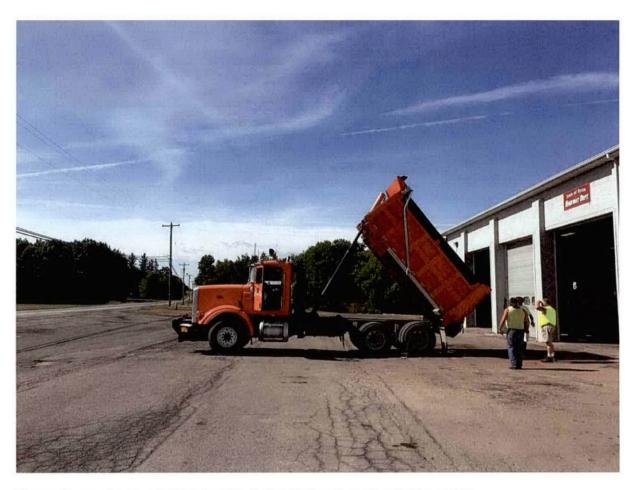
Measuring necessary height for the dump body when in raised position.

The barn's dimensions seriously limit the effectiveness of the Highway Department team to perform necessary repairs and maintenance. Currently, there is not enough space inside the garage to work on the snowplows and other trucks owned by the Town during the winter months. Indeed, there is not enough space to house a fully loaded snowplow inside the building, and it is not possible to lift its cargo in order to perform certain maintenance tasks. Moreover, the inadequate height of the roof presents a danger to the mechanics, since safety equipment on the trucks are only effective when they are in the fully raised position.

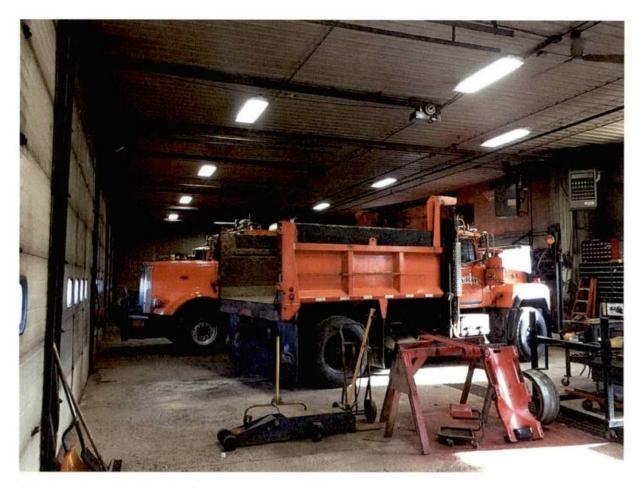
Interior view, showing inadequate egress width.

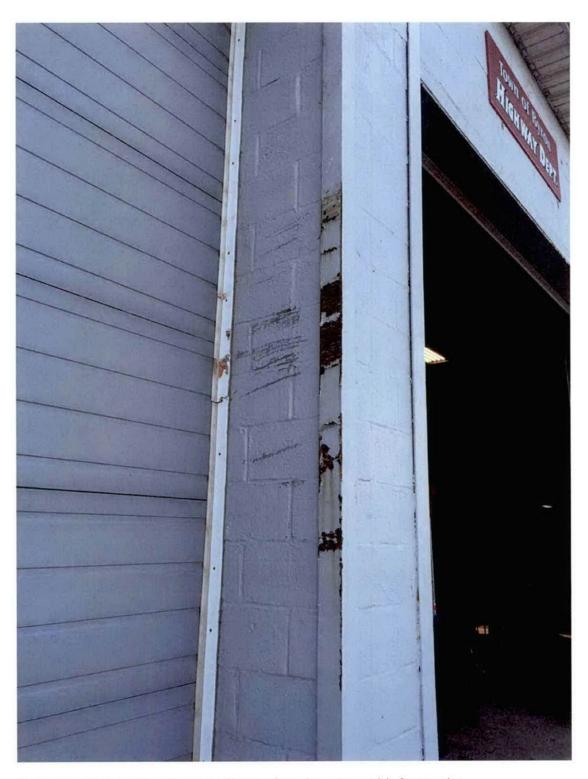
Overhead door jamb, showing effects of inadequate width for trucks.

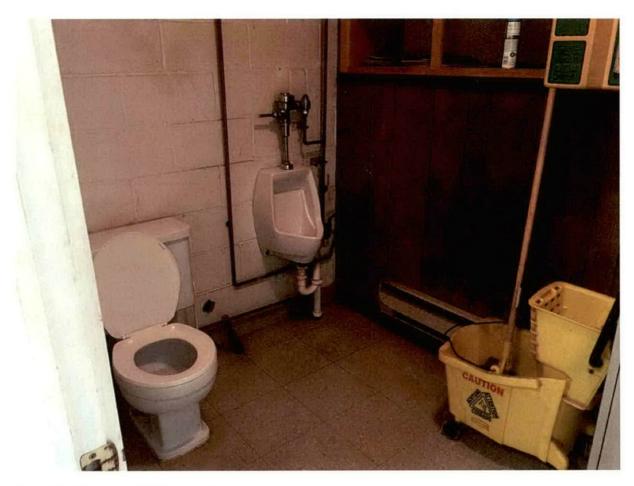
Toilet facilities not ADA compliant.

The existing kitchenette and bathroom are in a usable condition, but are not ADA compliant. We recommend performing minimal improvements in these areas to make them compliant.

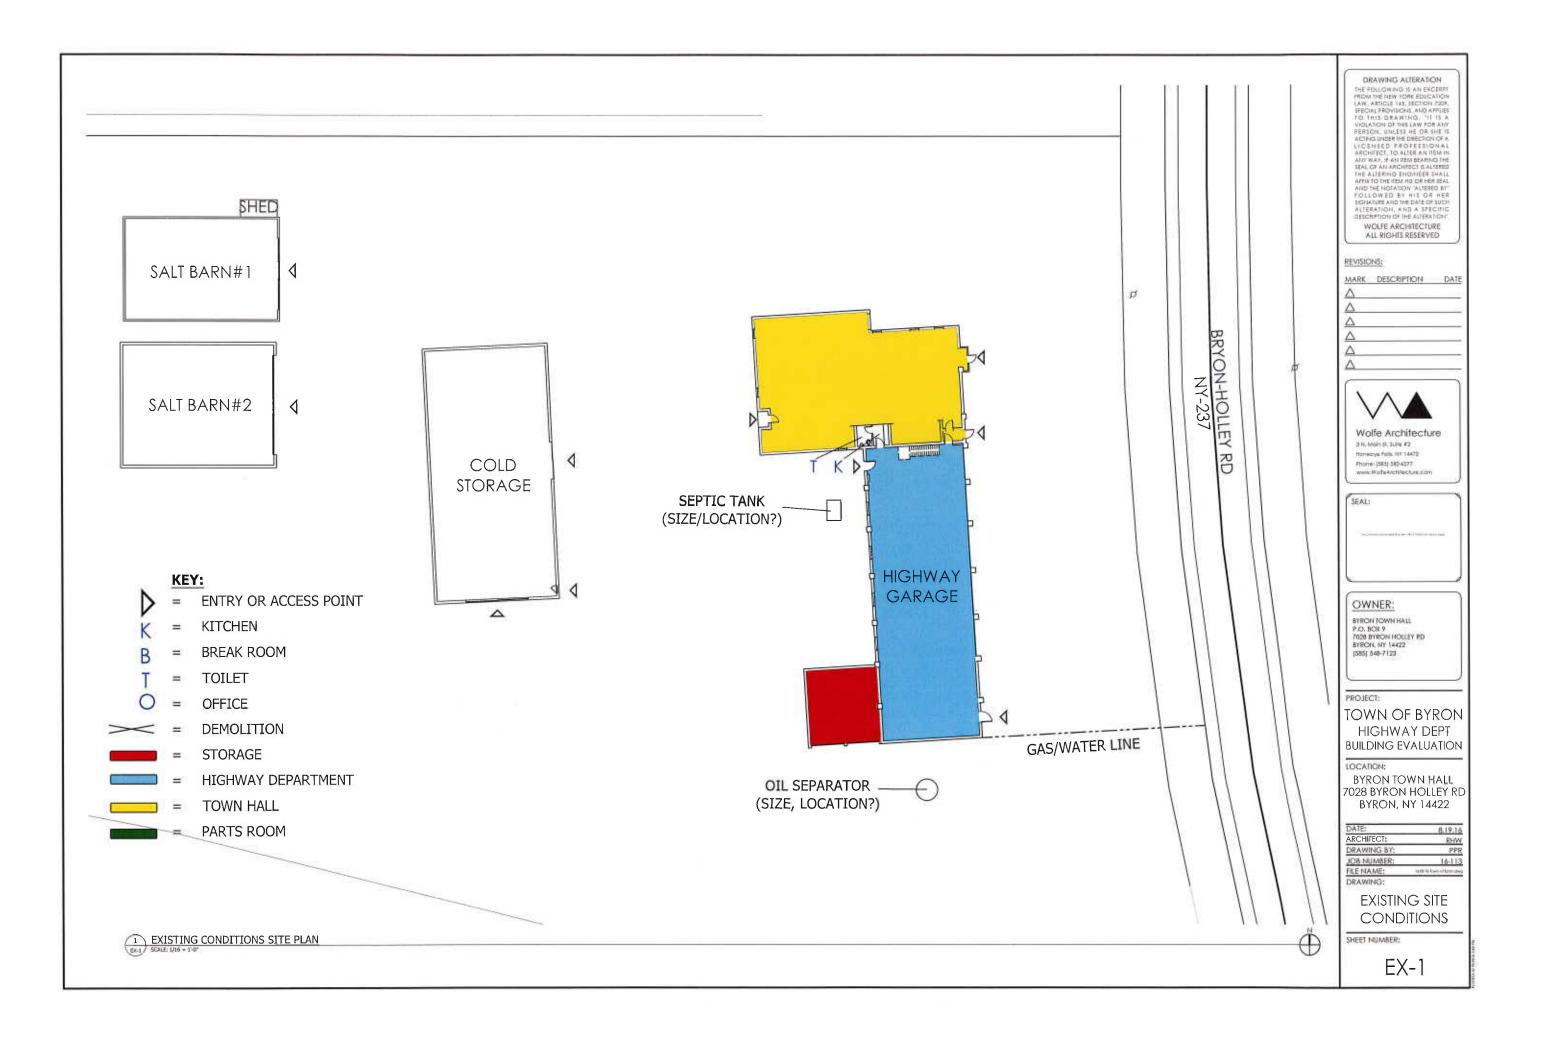
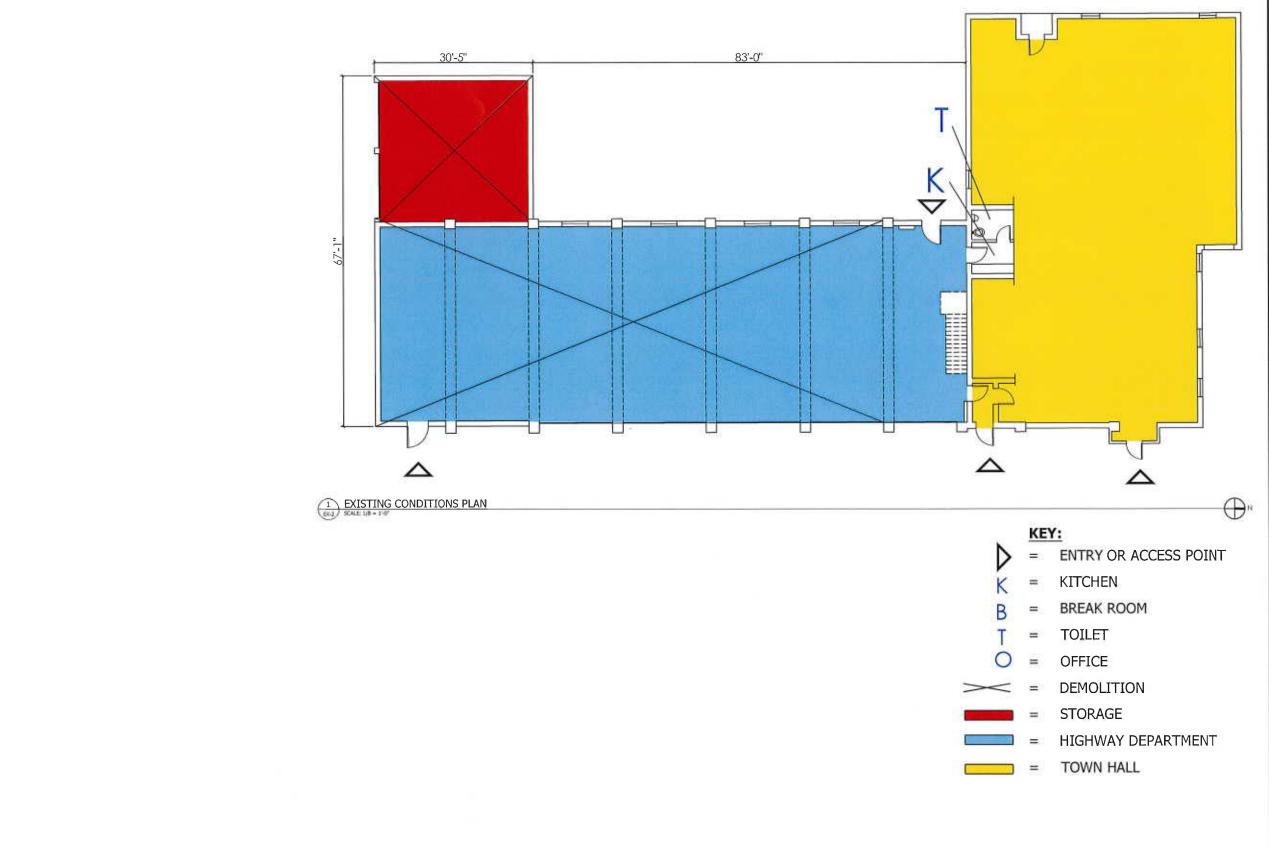
EX-2

EXISTING PLAN CONDITIONS
